台 湾 地 震 交 通 調 査

報 告 書

平成 12 年 3 月

The Survey and Analysis of Road Damage and Traffic Condition for Transportation Networks

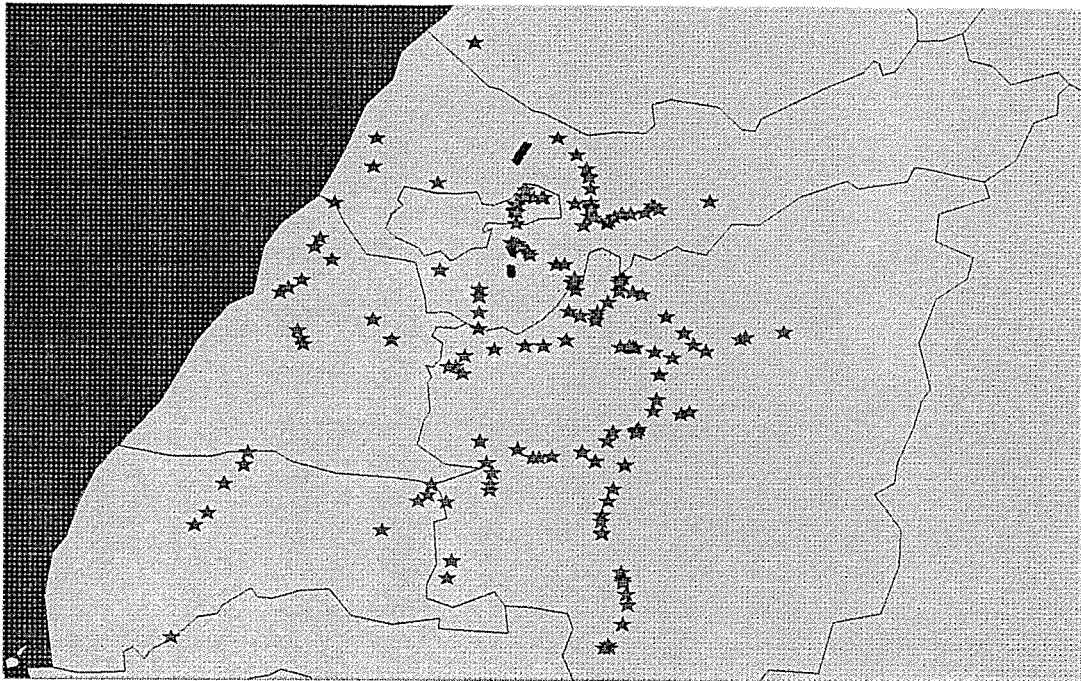
Figure 1-6 Distribution of Highway Damage Sites

The highway transportation disruption in the Chi-Chi great quake resulted primarily from landslide, fault rupture and liquefaction. Highway traffic were closed on 156 sites for provincial road and on 112 sites for county road. There were 290 sites having the road surface displacements and landslides. The locations of these damaged sites could be seen in figure 1-6.

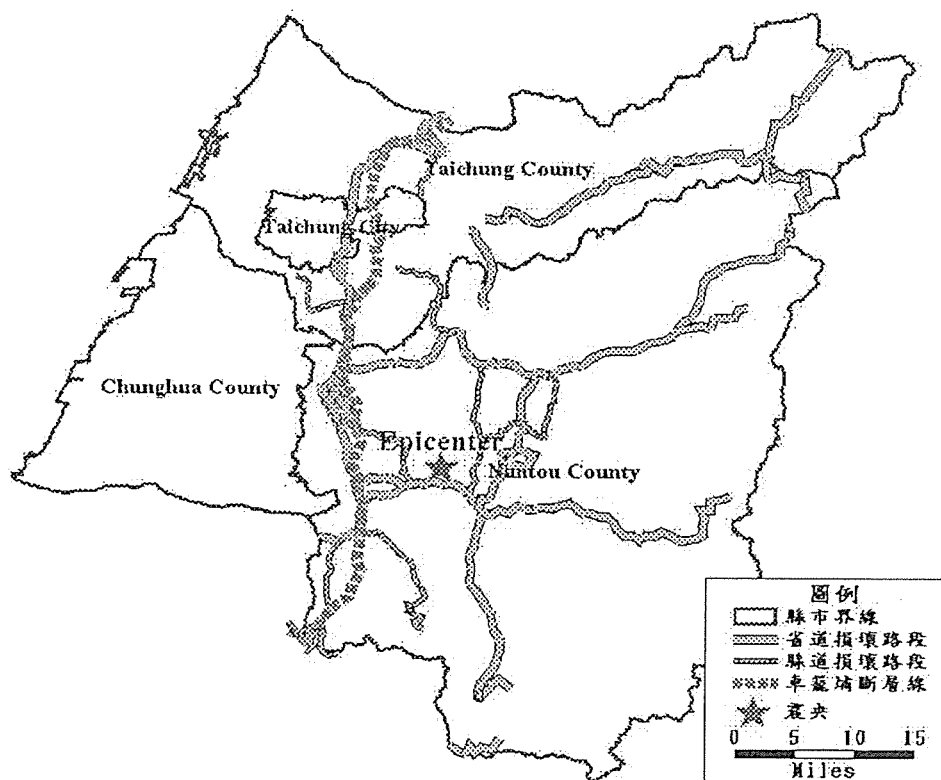
Figure 1-8 Distribution of Damaged Highway Routes

From the topography of disaster areas (figure 1-7), it can be seen that the seriously damaged highway sites or highway routes are located at mountainous areas which caused the landslides, or adjacent areas of fault rupture. The highway routes of major damage were No. 3, No. 8, No. 8-1, No. 14, No. 16, No. 18, No. 21, and No. 21-1 at the provincial highway level, and No. 131, No. 136, No. 149, No. 149-1, No. 149-2, No. 151 at the county highway level (Table 1-1).

Among these, Provincial-3 is a very important north-south highway routes, which is unfortunately located adjacent to the Chelungpu fault. Provincial-8, -14, -16, and -21 were basically the mountainous highway routes, which were damaged because of the landslide, rockfall and surface displacement. The distribution of damaged highway routes can be seen in figure 1-8. The other reasons for damaged provincial-3 and -14-2 highway routes are liquefaction. The reasons and locations for highway damages can be summarized as in the figure 1-9.

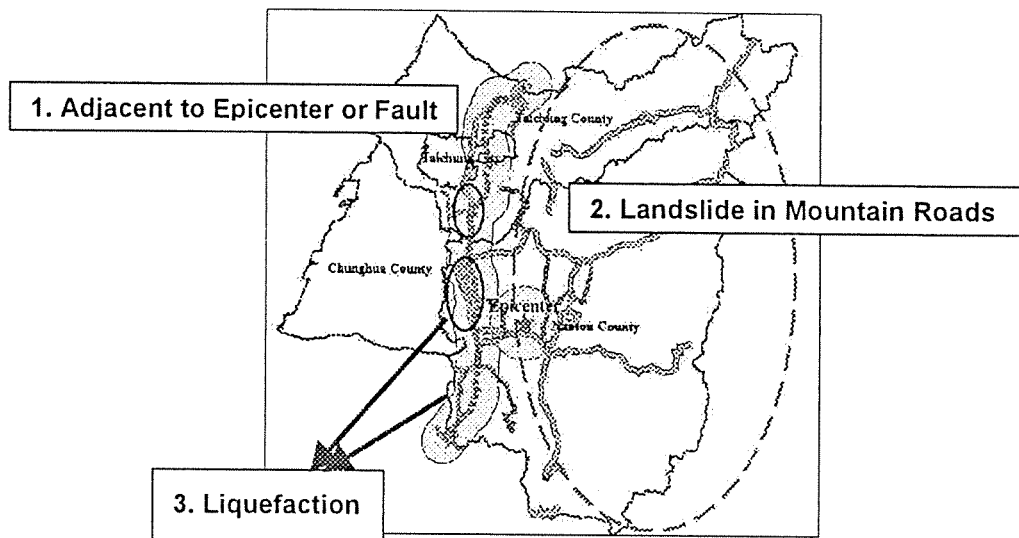
Figure 1-9 Major Reasons for Highway Damage

Fault rupture and ground shaking are two major reasons to cause the highway damages. Provincial-3 highway is a typical example. The other reason of highway damage is from landslide particularly in mountainous areas, and Princial-8, Princial-14, Princial-18 and princial-21 are these examples. Liquefaction is another reason to cause the highway damage.

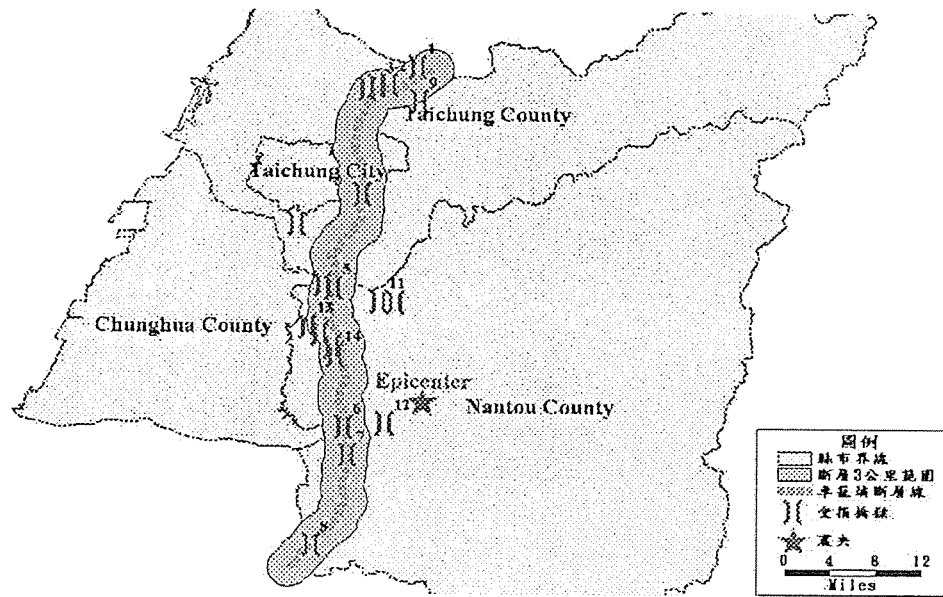
Figure 1-10 Relationship between Bridge and Fault

Bridges are the most vulnerable component of the transportation system. Nearly every bridge along the Chelungpu Fault was seriously damaged or destroyed. Although Chi-Chi earthquake damaged more than 85 bridges, 13 of these belonged to the sites of major or medium damage identified by the Taiwan Highway Bureau. Some bridges failed due to fault rupture beneath or adjacent to them. Examples for fault rupture were Shi-We Bridge, U-Shi Bridge, Min-Chu Bridge, I-Chiang Bridge, Tung-Tou Bridge, and etc. Some bridges failed due to ground shaking. Examples for ground shaking included Dong-Fung Bridge, Yen-Fung Bridge, Chi-Lu Bridge, and etc. Some bridges failed due to liquefaction. Examples for liquefaction had Mao-Lou-Shi Bridge, Jiun Kung Bridge and etc. The distribution of some bridges of major damage were illustrated in Figure 1-10.

The damage levels and damage reasons for major damaged highway bridges were summarized in the Table 1-2. It was found that most of seriously damaged bridges were adjacent to the fault rupture, which delivered a warning message to the transportation engineers who need to pay much attention on the location of fault and the structure of bridges in the future.

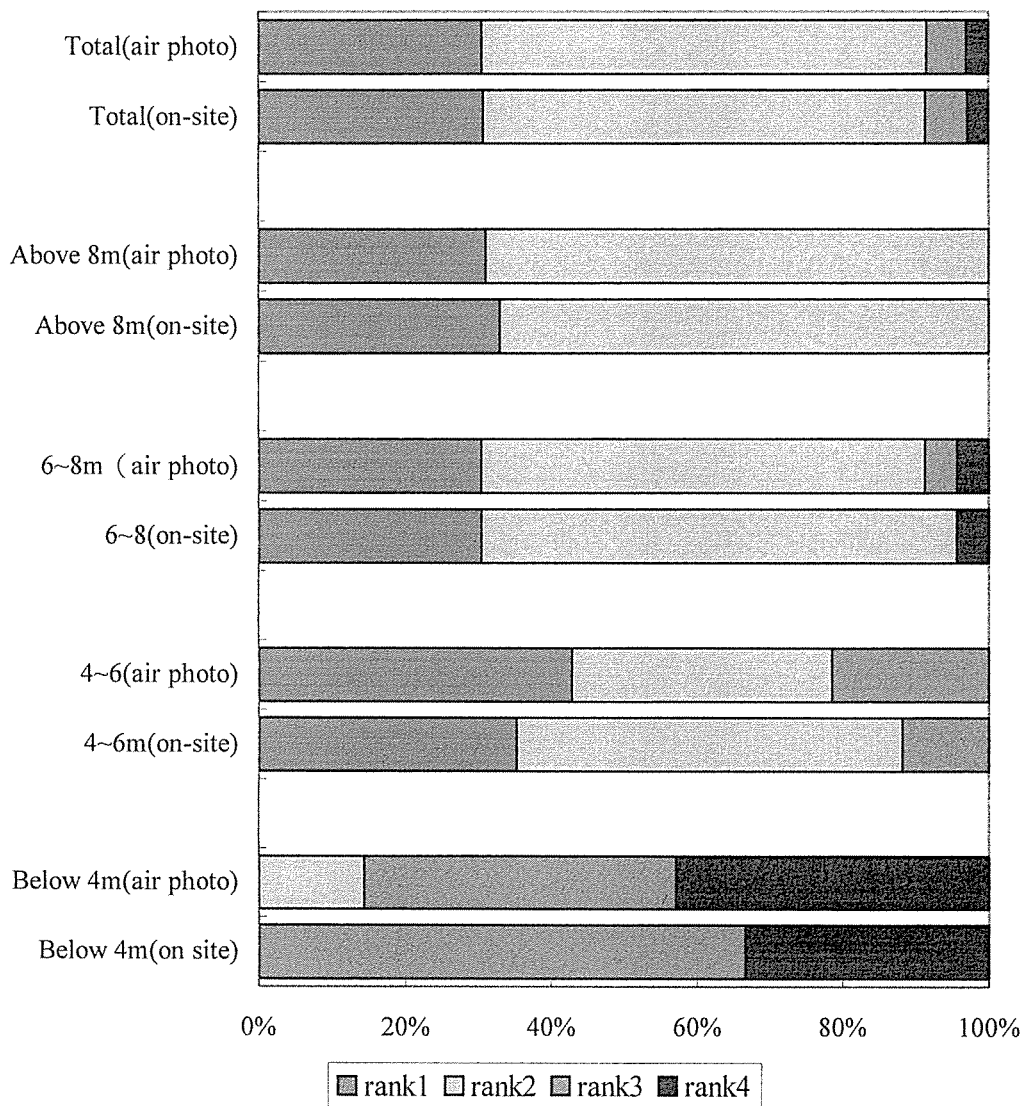
Figure 3-2 Street closures by street width

The relationship between street width and street damage is shown in Table 3-4 and Figure 3-2. Most of the levels of street damage are at rank1 and rank2. There are 4 links at rank4. Regarding the emergency vehicles, there are 11 (=7+4) links readable from the air photographic data and 12 (=8+4) links from the on-site survey. Street width of 4 meters locates in rank 3 and rank 4, and closed to emergency vehicles. Street width of 8 meters and above locates in rank1 and rank2, and all accessible by emergency vehicles. It is found that streets width between 6 and 8 meters can offer disaster-prevented function. Please also refer to Figure 3-3 and Figure 3-4.

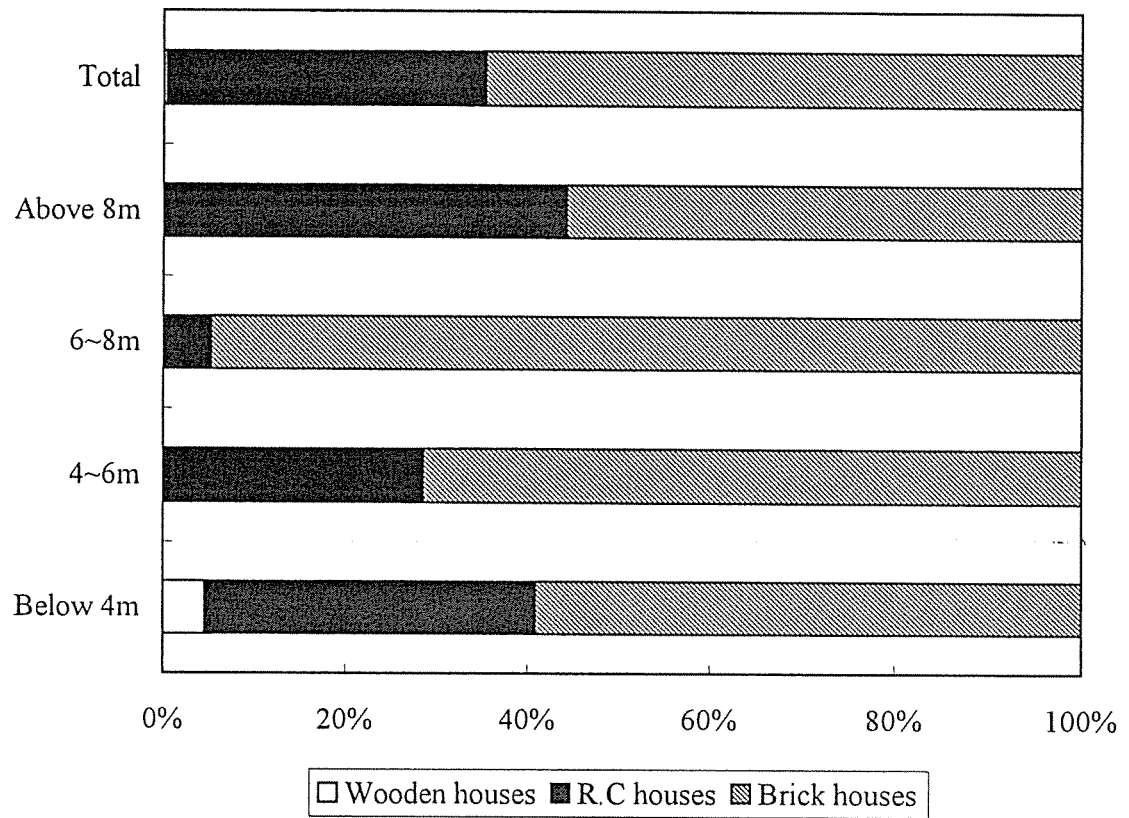
Figure 3-5 Street closure classified by collapsed building structure

The damage conditions of collapsed buildings and public facilities could not be read directly from the air photographic data, we have to reconfirm the conditions via on-site survey. The relationship between street width and collapsed building structure / public facilities is shown in Table 3-5 and Figure 3-5. There were a lot of brick houses collapsed, but wooden houses were relatively less. It was also found that many collapses of wire poles and walls in the streets whose width are between 6 and 8 meters.
