台 湾 地 震 交 通 調 査

報 告 書

平成 12 年 3 月

The Survey and Analysis of Road Damage and Traffic Condition for Transportation Networks

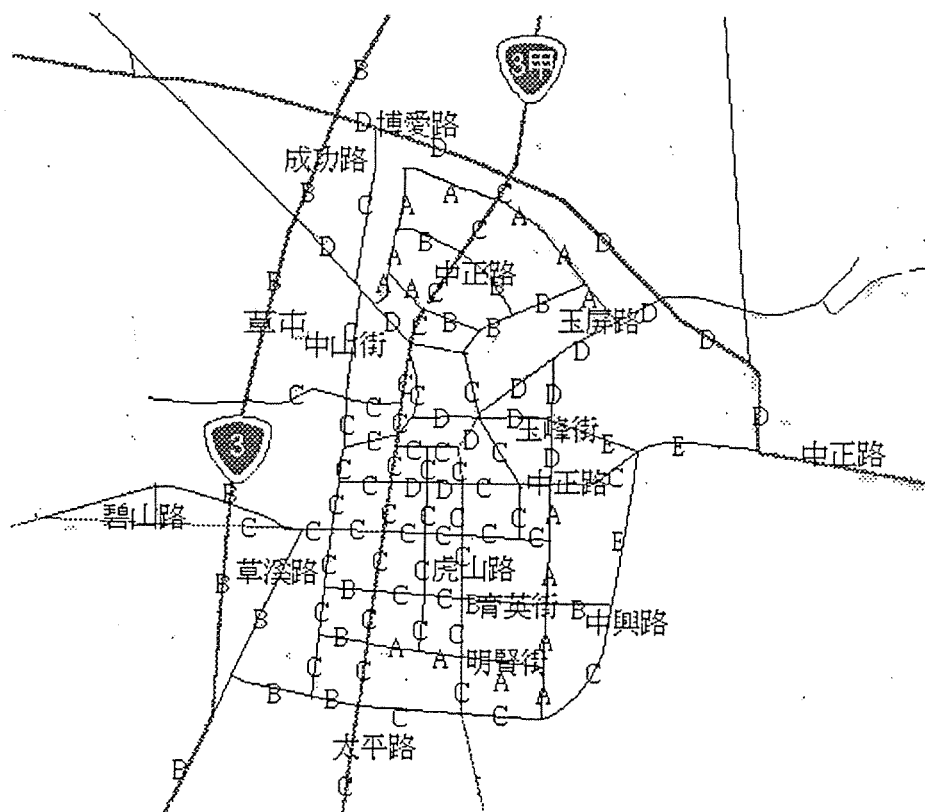
Figure 2-7 Level of Service Change B/A Quake in Tsaotung Town

Traffic congestion levels in terms of LOS after 2 weeks of the quake in Tsaotun Town are shown in figure 2-7, and the change of LOS is shown in figure 2-8.

- B. For those segments with a thick block line, it means that the link segments were damaged by fault rupture. Thus, the significant degrade of LOS are due to fault rupture.
- C. The area with shadow means that there are collapsed buildings in that specific area. Since the earthquake damage is not serious, the urban street network remains much the same as before. Therefore, the traffic conditions are similar to those before the quake. The only degrade of LOS is due to fault rupture, which causes backup queue in some street segments. The other one is on the way west to Puli due to increasing traffic demands.

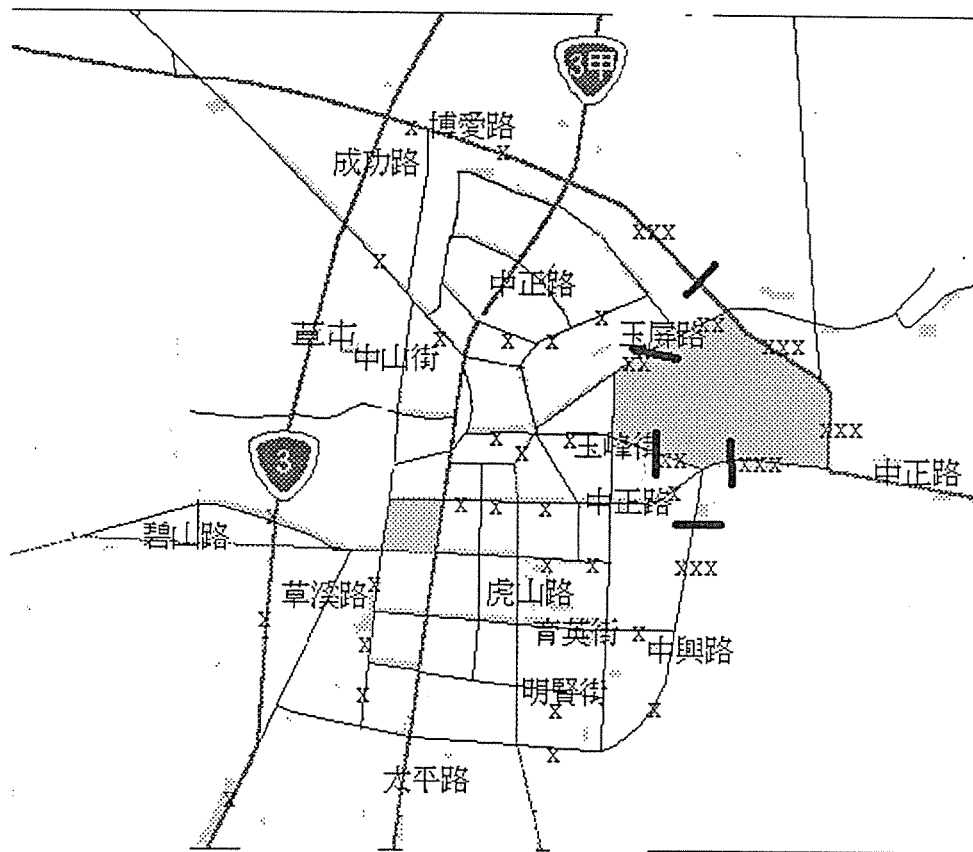
Figure 2-8 Level of Service Change B/A Quake in Tsaotung Town

(2) Description of the change of LOS's after the quake (figure 2-8)

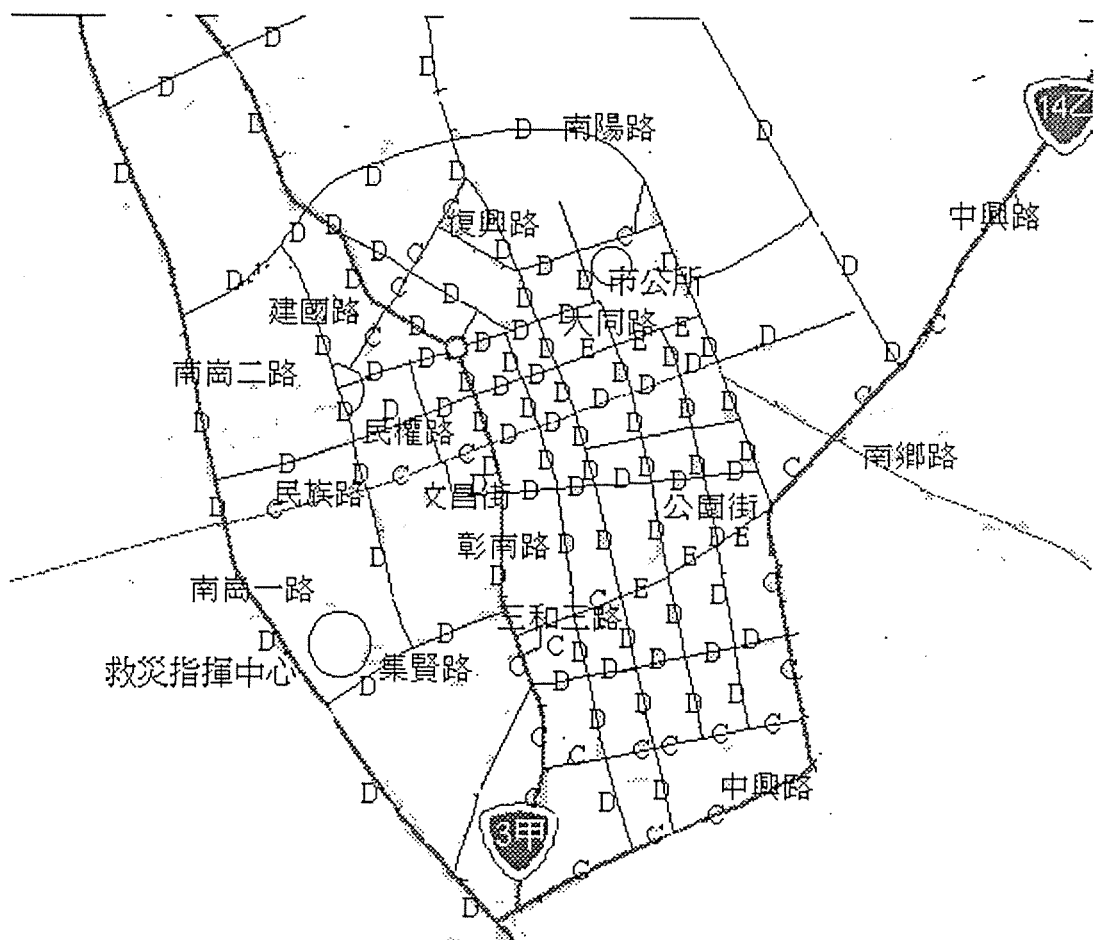
Figure 2-9 Level of Service Change B/A Quake in Nantou City

- A. The links with trunk lines are 4-lane, provincial-level highways, including Nankang 1st Road, Nankang 2nd Road, and Chunshing Road. The rest of the links are 2-lane urban streets.

- B. In the survey, there are totally 127 link segments being investigated, in which 25 segments with LOS of C, 96 segments with D, and 6 segments with E.
- C. The LOS's for most of the links in the study area are at D level.
- D. The main rescue center is located at Nankang Road. The center is the temporary administration office of Nantau County Government. It also acts the dispatching, rescue, and resource collection / distribution headquarter. The city government office is located at the corner of Tatung Street and Nanyang Road. This office is for general administration business and rescue resource collection / distribution center.

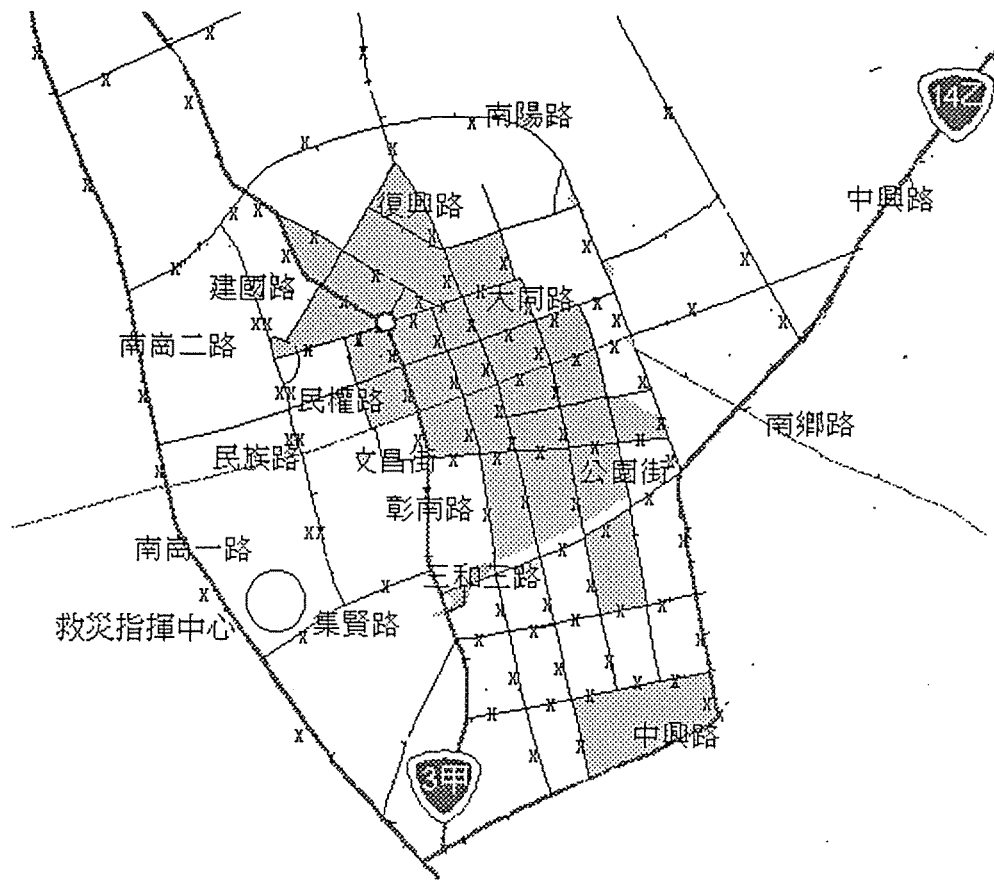
Figure 2-10 Level of Service Change After Quake in Nantou City

- C. The areas with shadow mean that there are collapsed buildings in those specific disaster areas. The damage situations in Nantau City are more serious. Almost all the links west to Provincial-3 highway is influenced by collapsed buildings. After two weeks of the quake, most of the lanes are closed in view of the potential danger of collapsed buildings, which results in significant degrade of LOS's.

- D. In spite of the serious traffic conditions caused by lane closure, the responses collected from the survey in terms of LOS's are general at level D, with some responses of level E. This is due to lane closure control is periodically conducted in case it is necessary based on actual needs, and the survey was conducted two weeks after the quake, therefore the traffic pattern becomes stable. This outcome is significantly different from that of air photographing data in which highway condition is generally classified into two types: "in service" and "blocked".

- E. In the neighboring areas of the rescue center, which are newly developed space; the buildings are slightly damaged. However, the LOS's of connecting highways, such as Nankang Road and Changnan Road are degraded. This is due to increased demands of rescue vehicles. Similar situation is found in Nanyang Road, which connects the rescue center and the city government office.

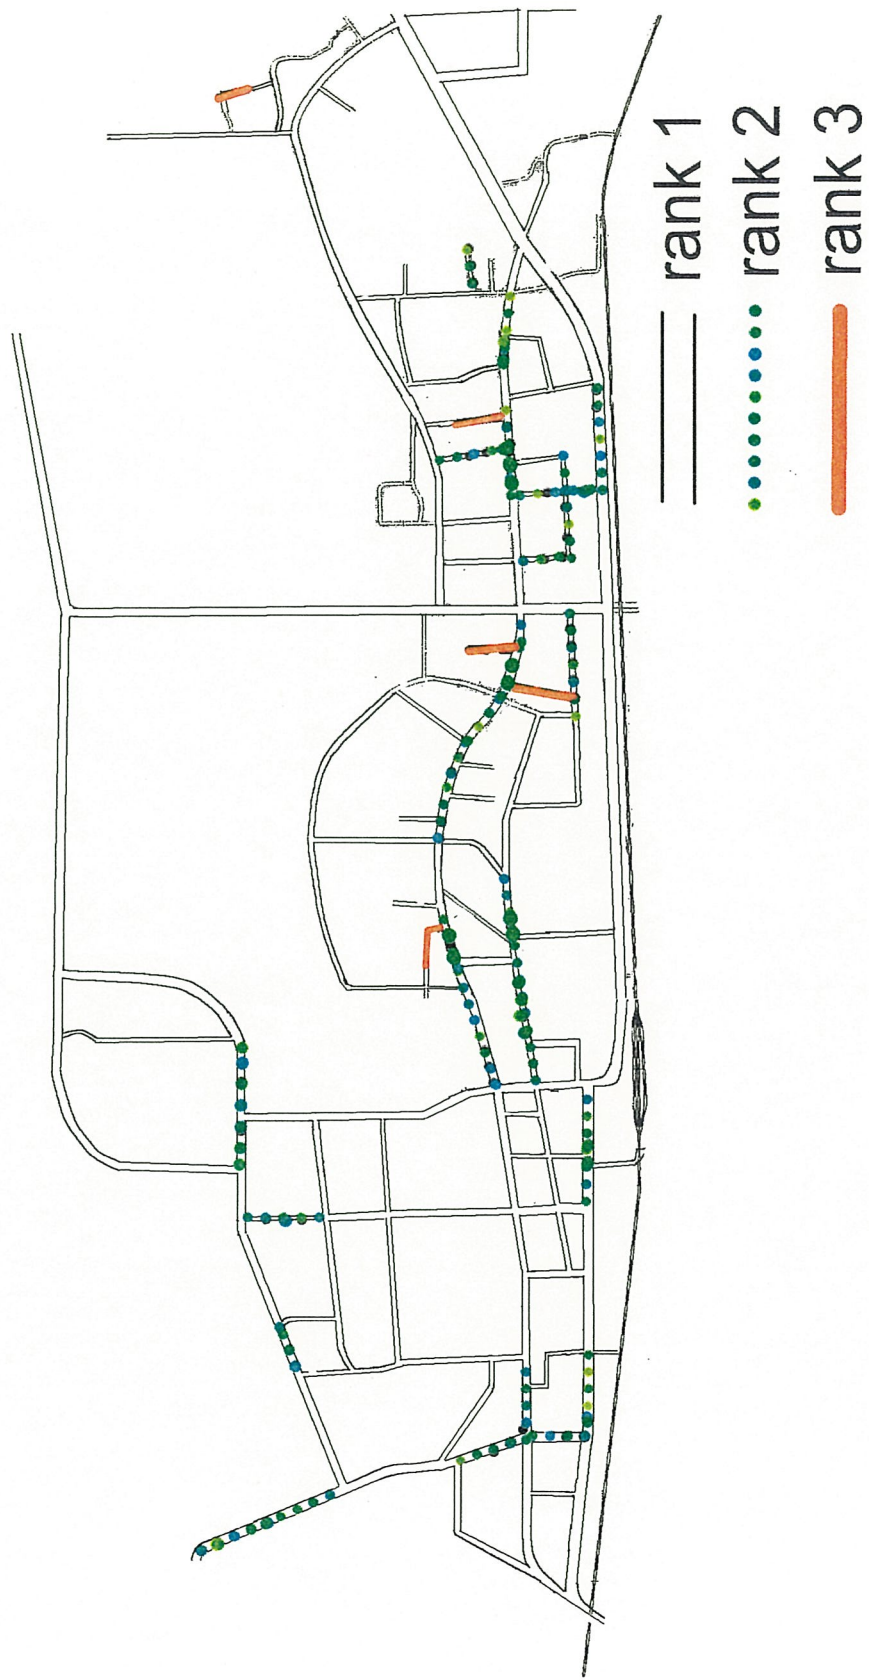
Figure 3-3 Street damage based on on-site surveys in Chi-Chi

The relationship between street width and street damage is shown in Table 3-4 and Figure 3-2. Most of the levels of street damage are at rank1 and rank2. There are 4 links at rank4. Regarding the emergency vehicles, there are 11 (=7+4) links readable from the air photographic data and 12 (=8+4) links from the on-site survey. Street width of 4 meters locates in rank 3 and rank 4, and closed to emergency vehicles. Street width of 8 meters and above locates in rank1 and rank2, and all accessible by emergency vehicles. It is found that streets width between 6 and 8 meters can offer disaster-prevented function. Please also refer to Figure 3-3 and Figure 3-4.

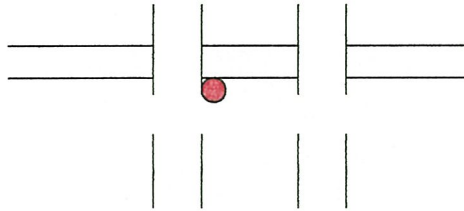
Damage on one end of the street
